Current status of storm drainage systems installed at FMCP

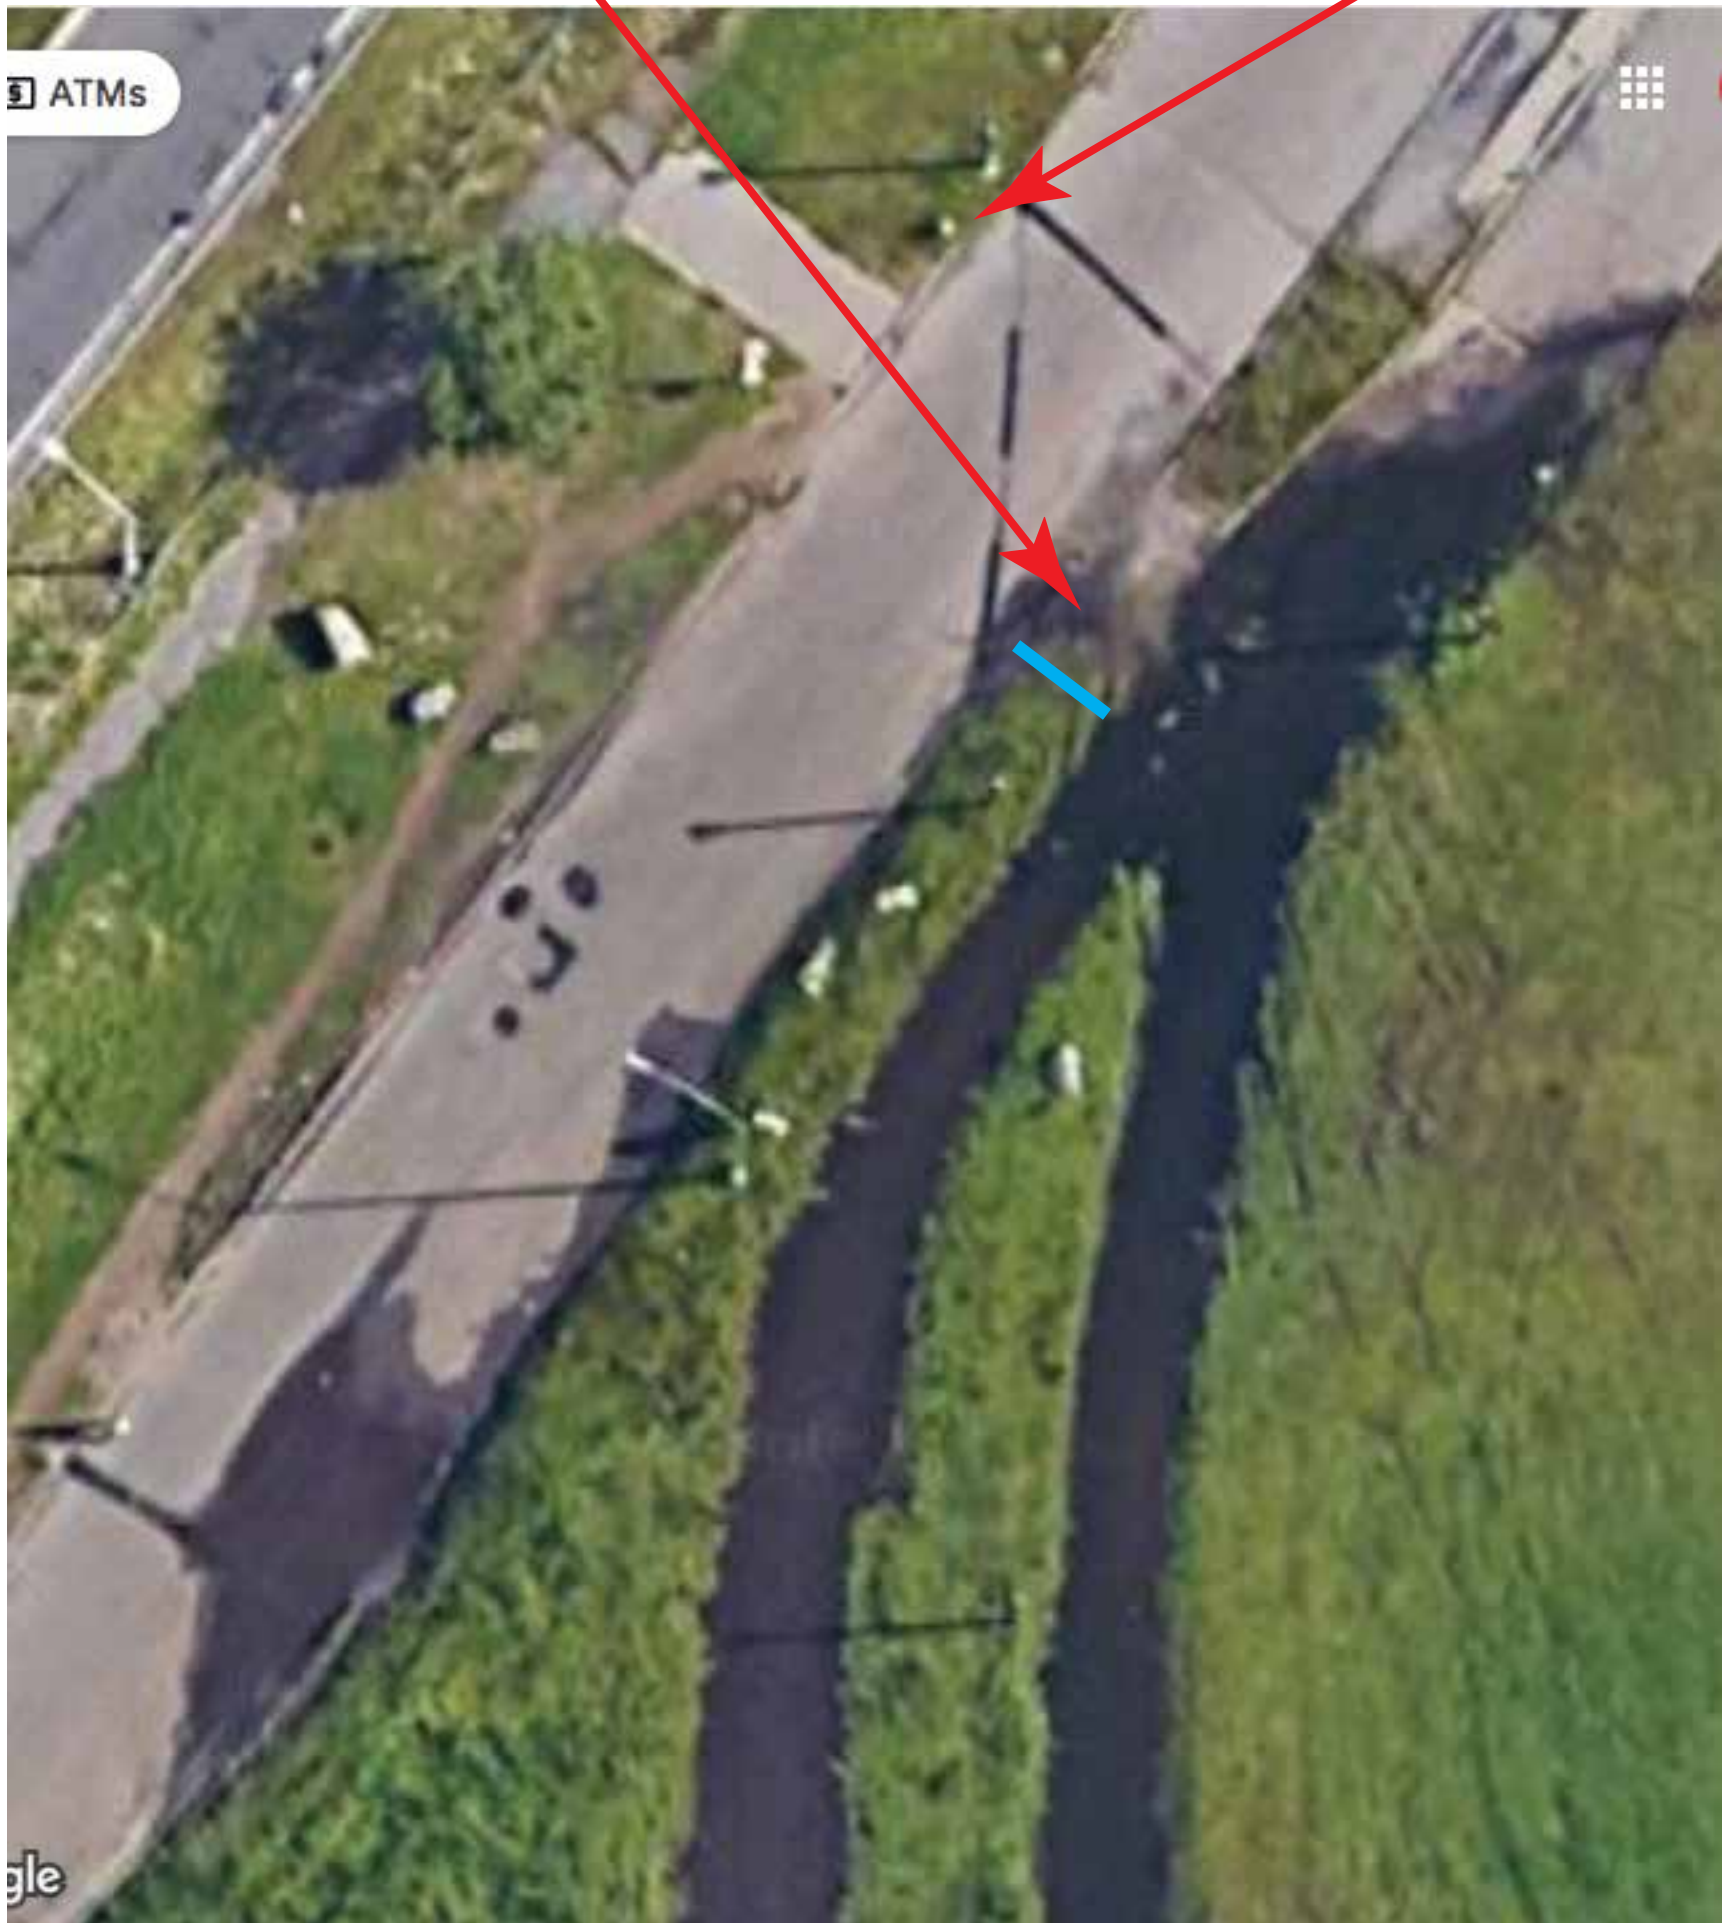
I suspect pipe rupture underground.  
Water comes out at much higher spot than anywhere  
around and refilling puddle pictured at page 3. I removed  
soil to the curb from paved roads around while I was trying  
to locate the source of the water.  
Needs further investigation.

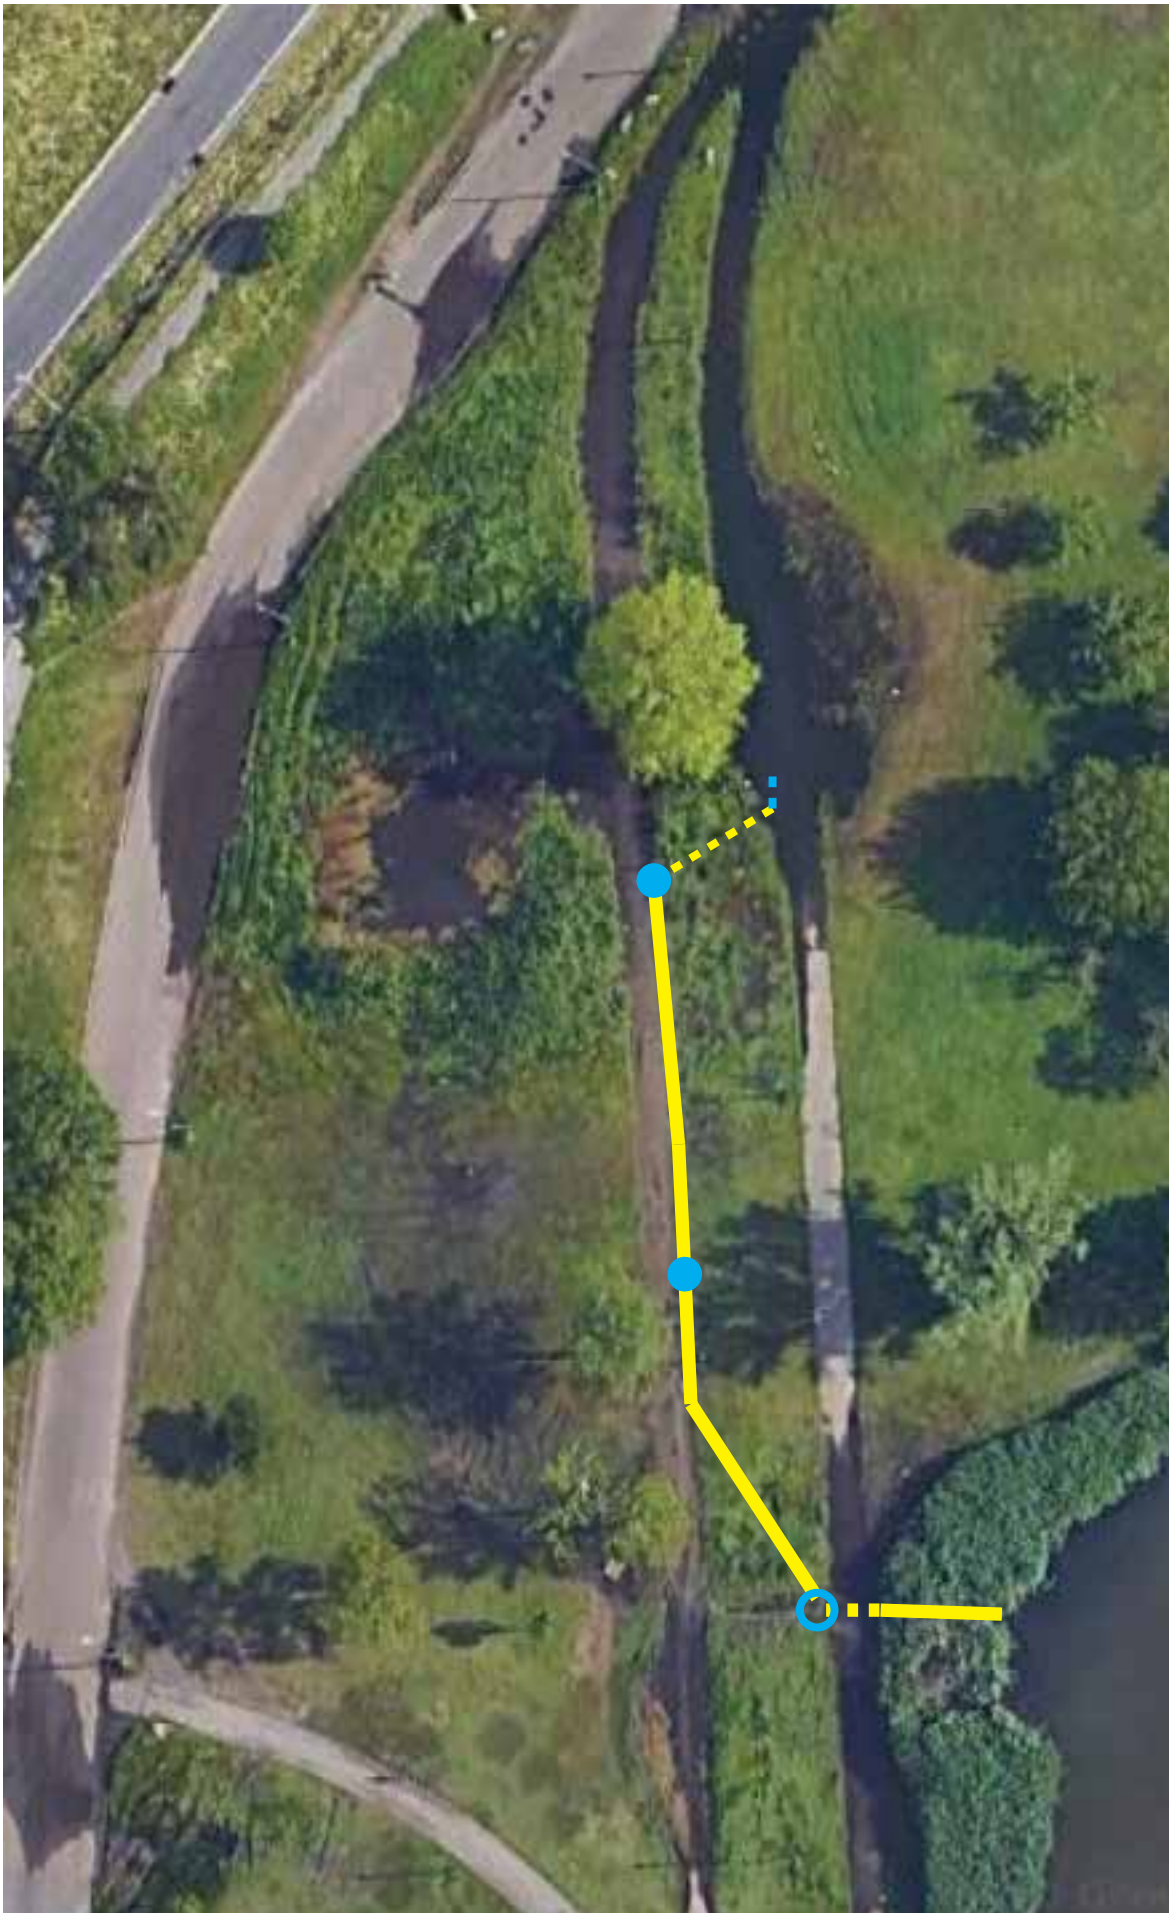
Status: Essential part is complete

6" pipe was installed from the tree to pedestrian path to keep up with heavy water flow. Dashed lines show open trench that need to have pipe installed in order to keep pedestrian path dry before covering. Also, catch basin and 6" rigid pipe need to be installed across pedestrian path to keep it dry.

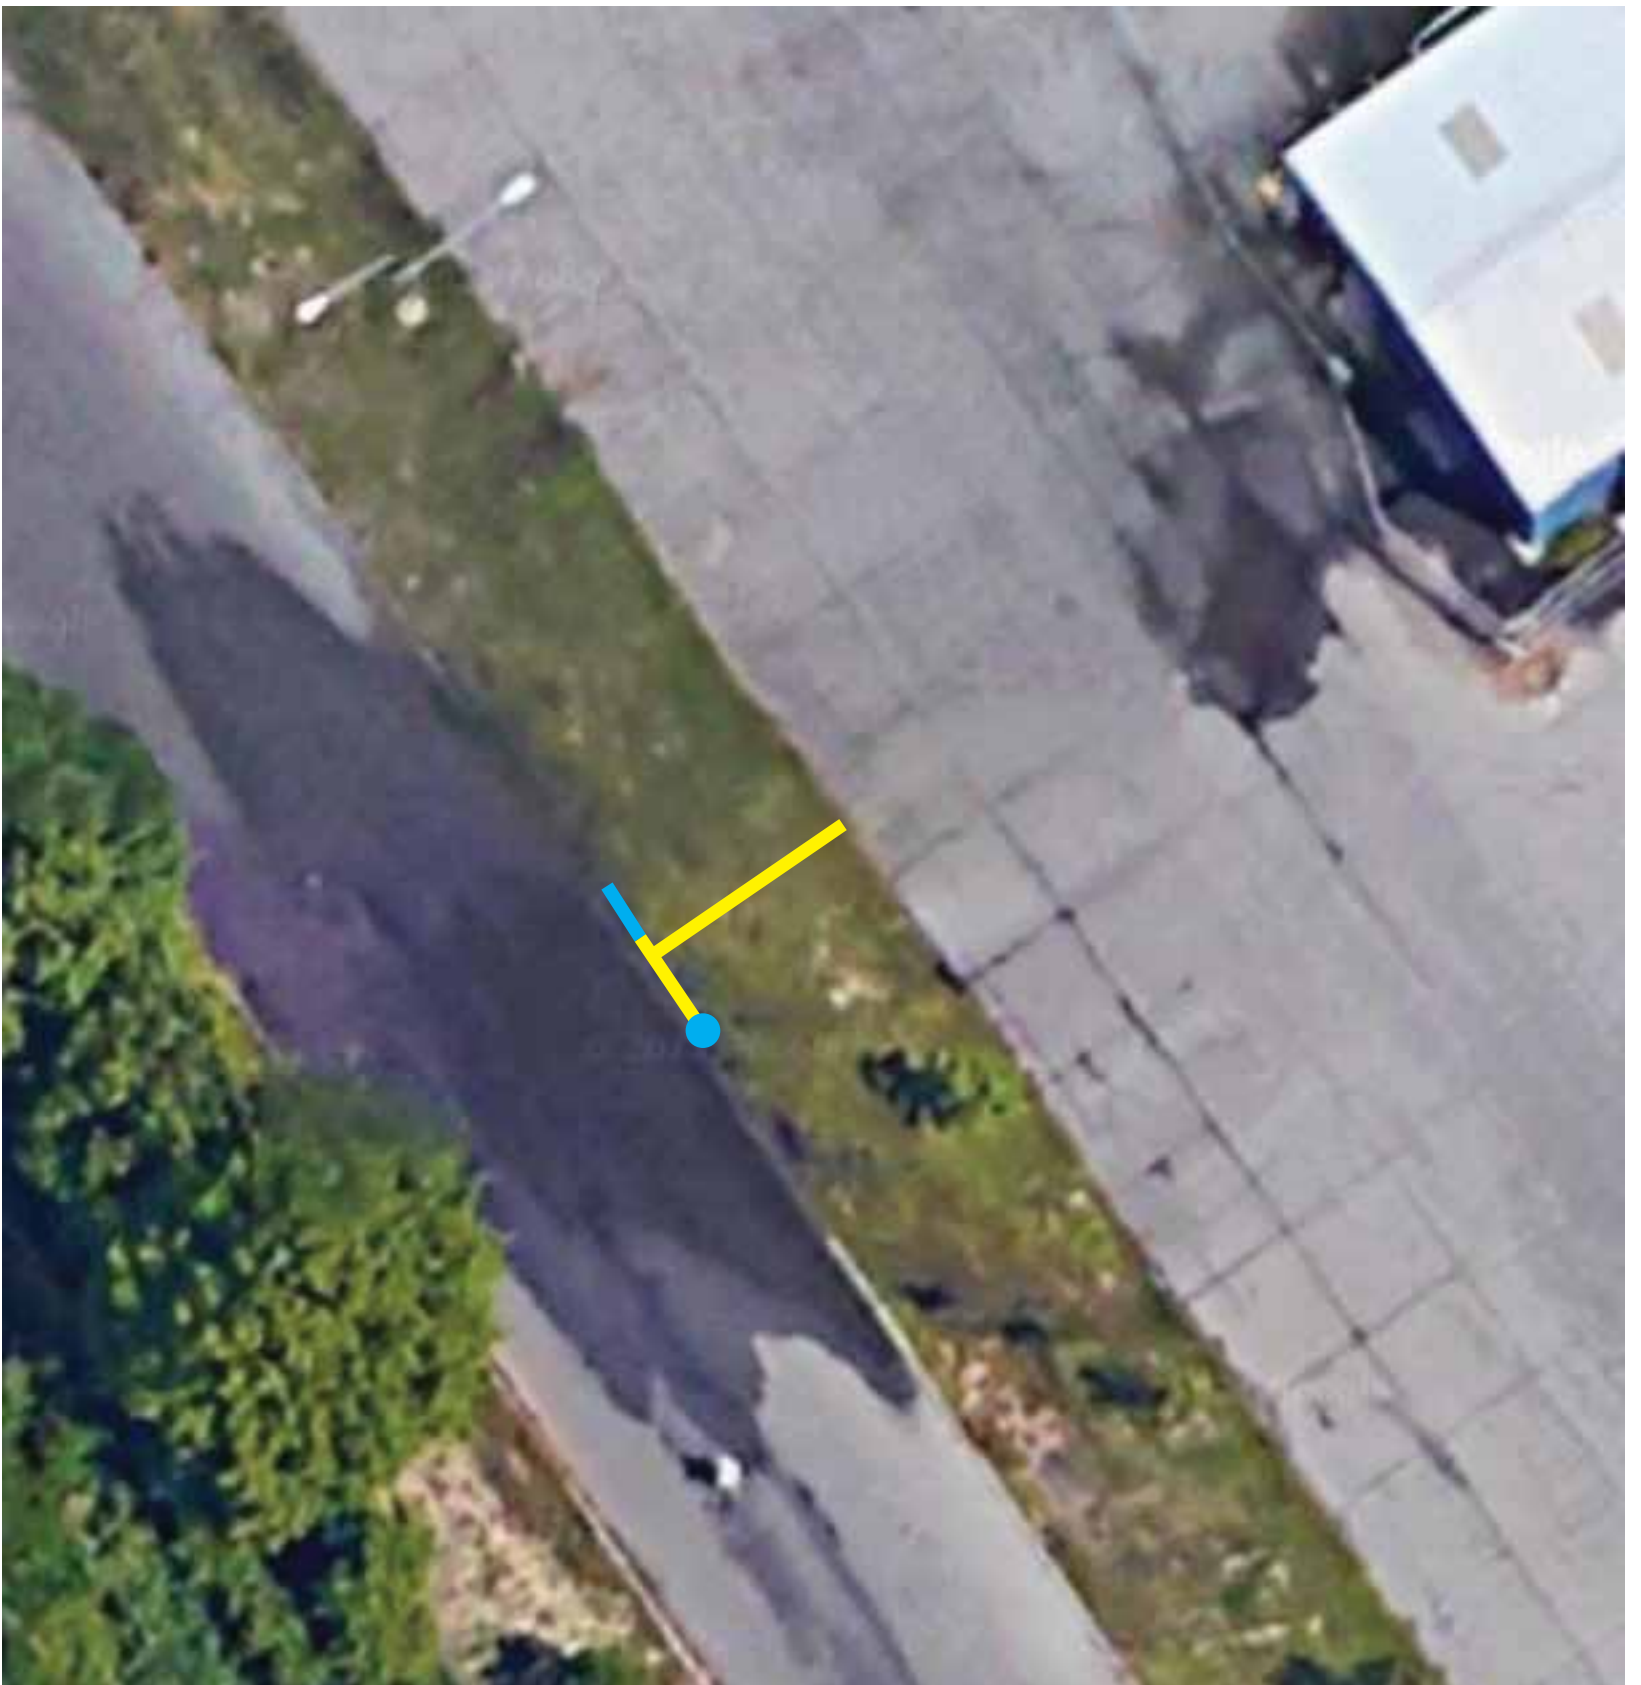
Status: Complete.

Channel drain and round grate were installed on the side of the road. Pipe follows natural water flow and lets water out to the parking lot.

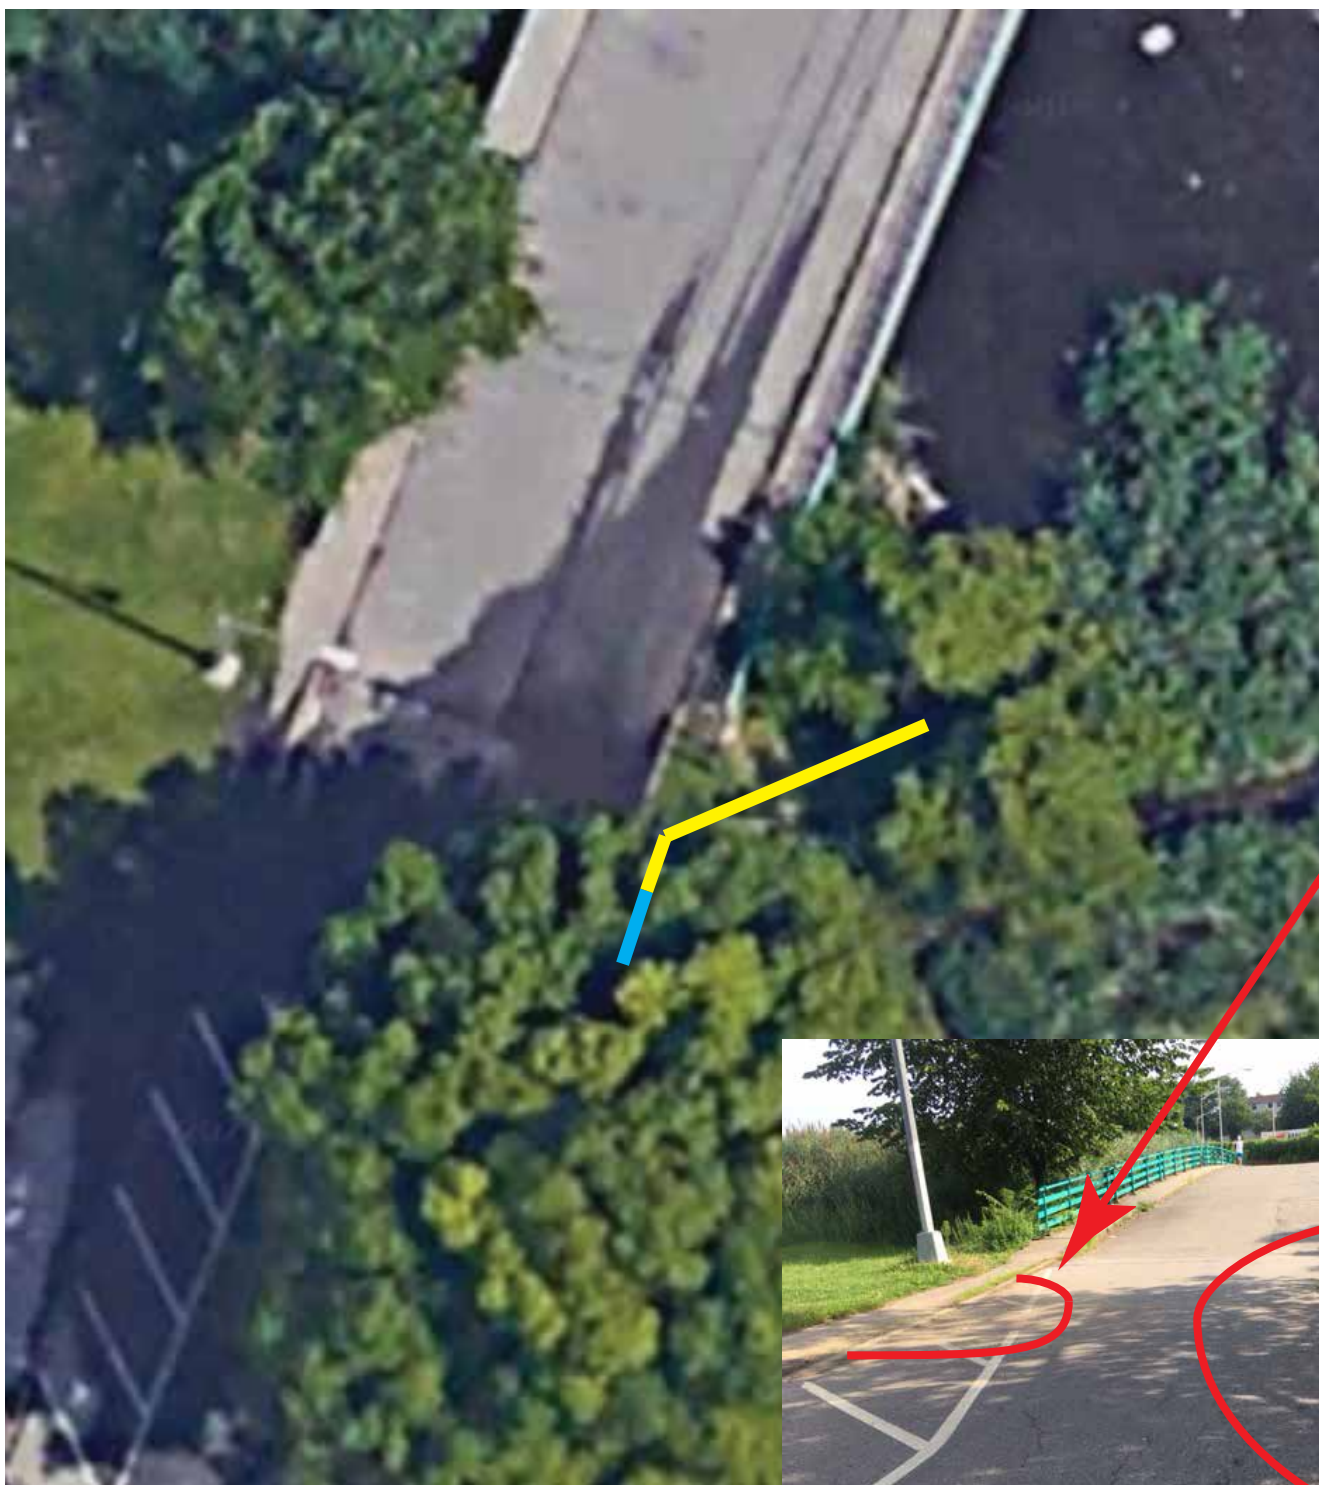
Status: Complete.

Channel drain was installed on the side of the road. Pipe turns 45 degree about 48" from the grate.

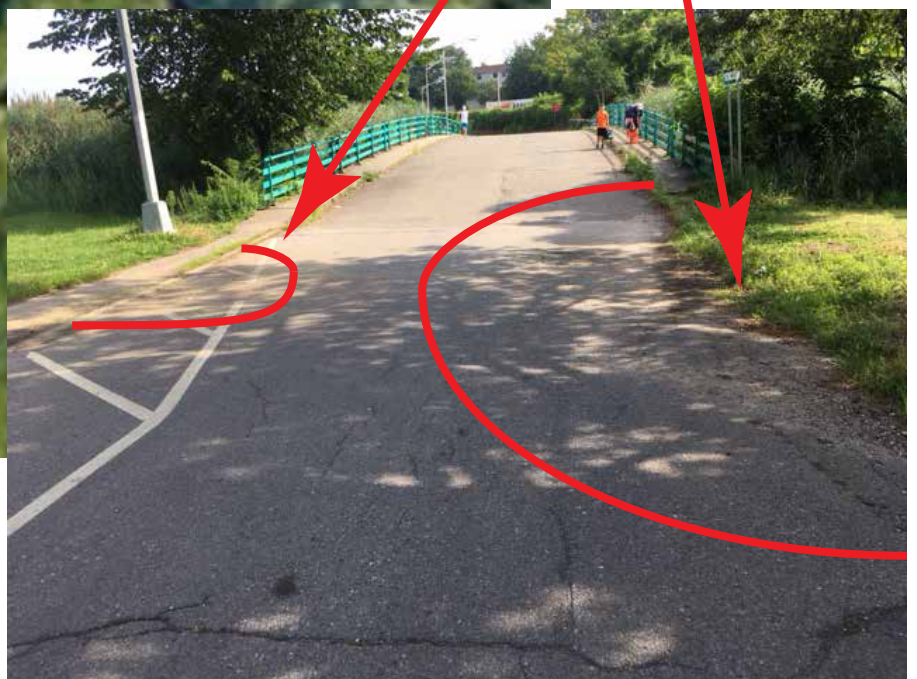
This puddle is very deep, but on the side of the road. Can be easily filled up with asphalt

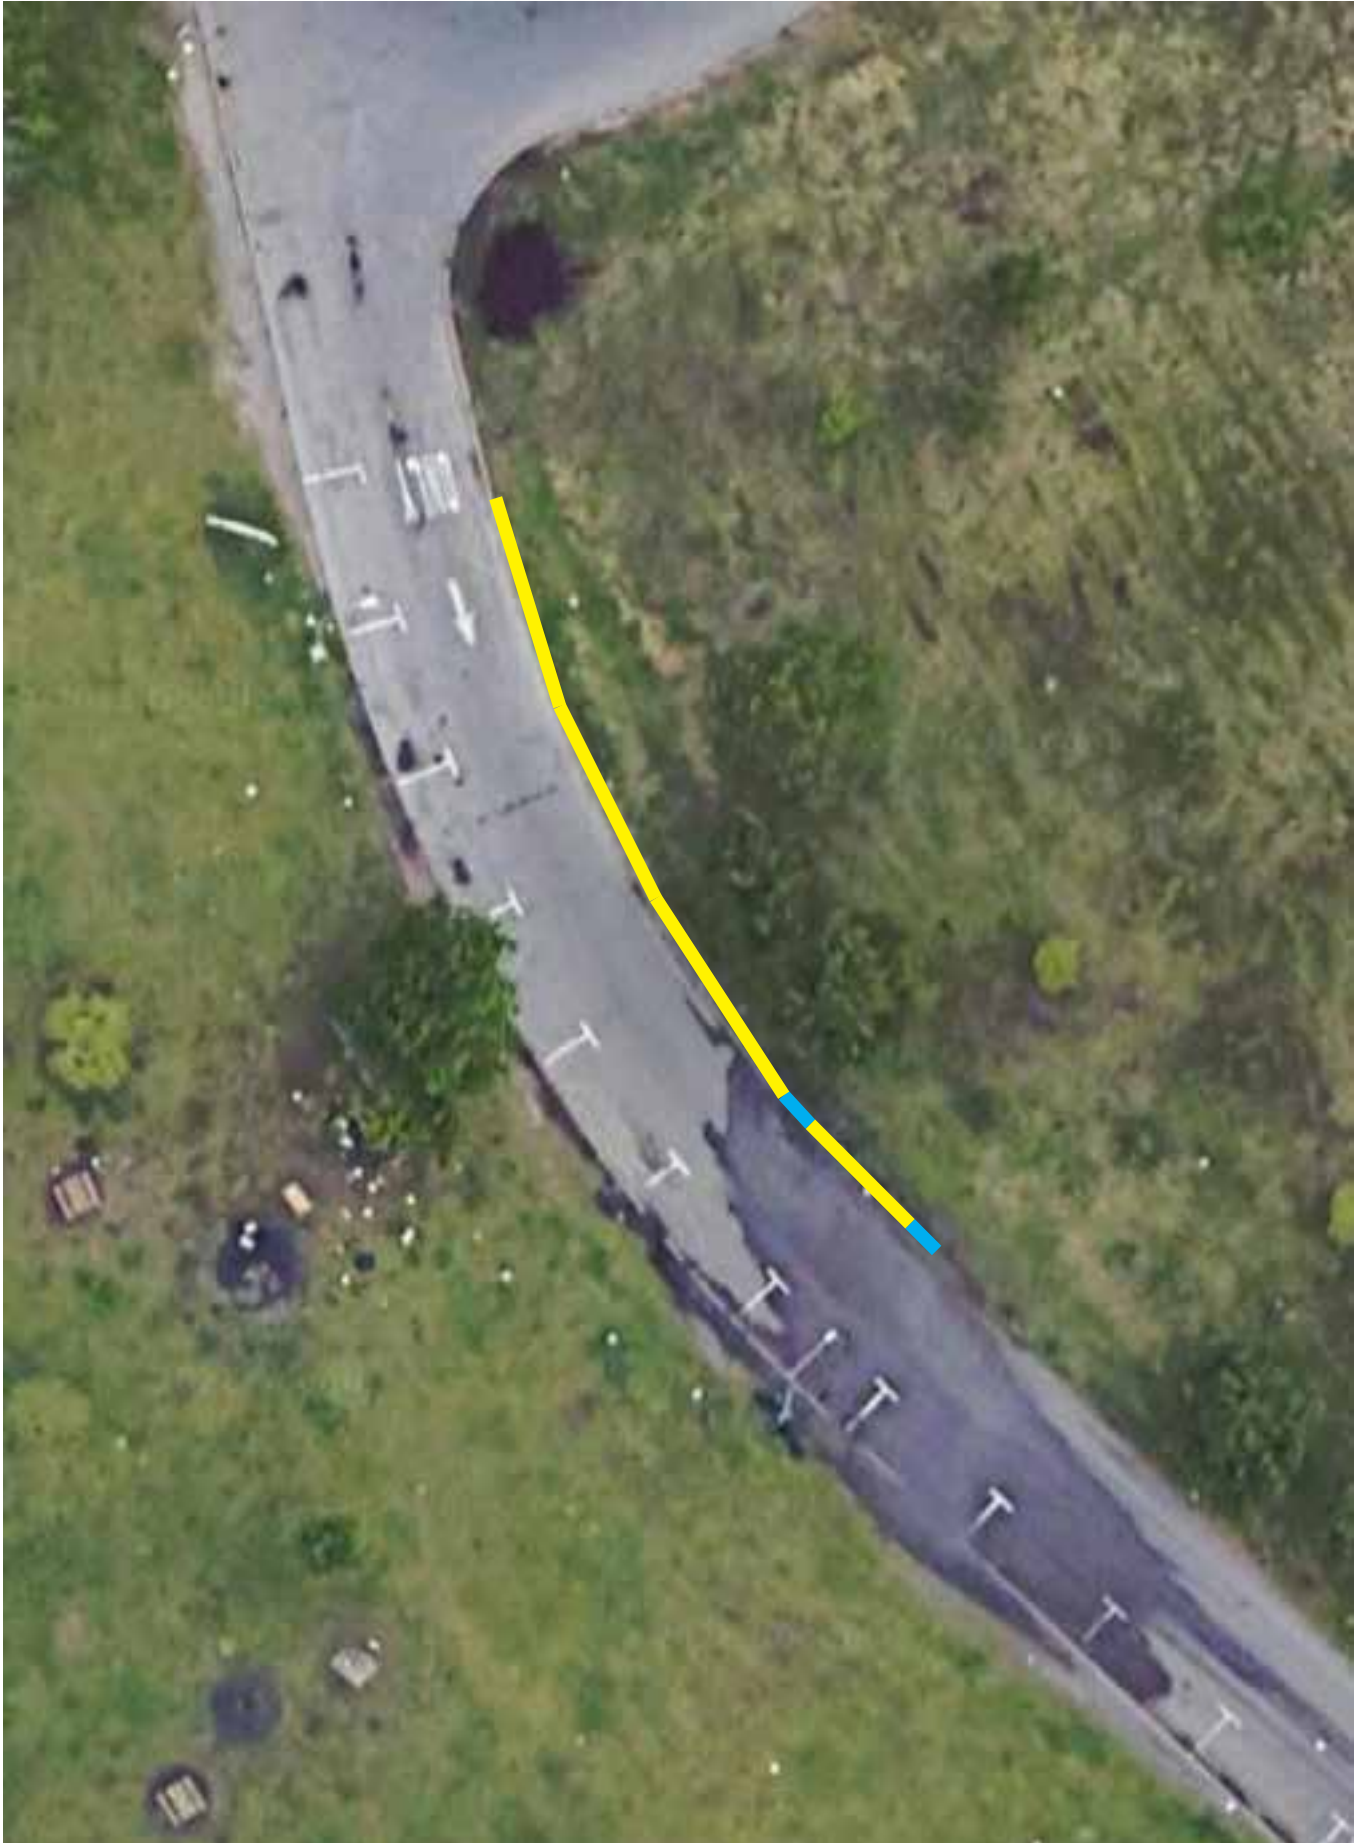
Status: Complete.

This 2 puddles required 2 channel drains to be installed on the side of the road. Pipe lets water out to the road

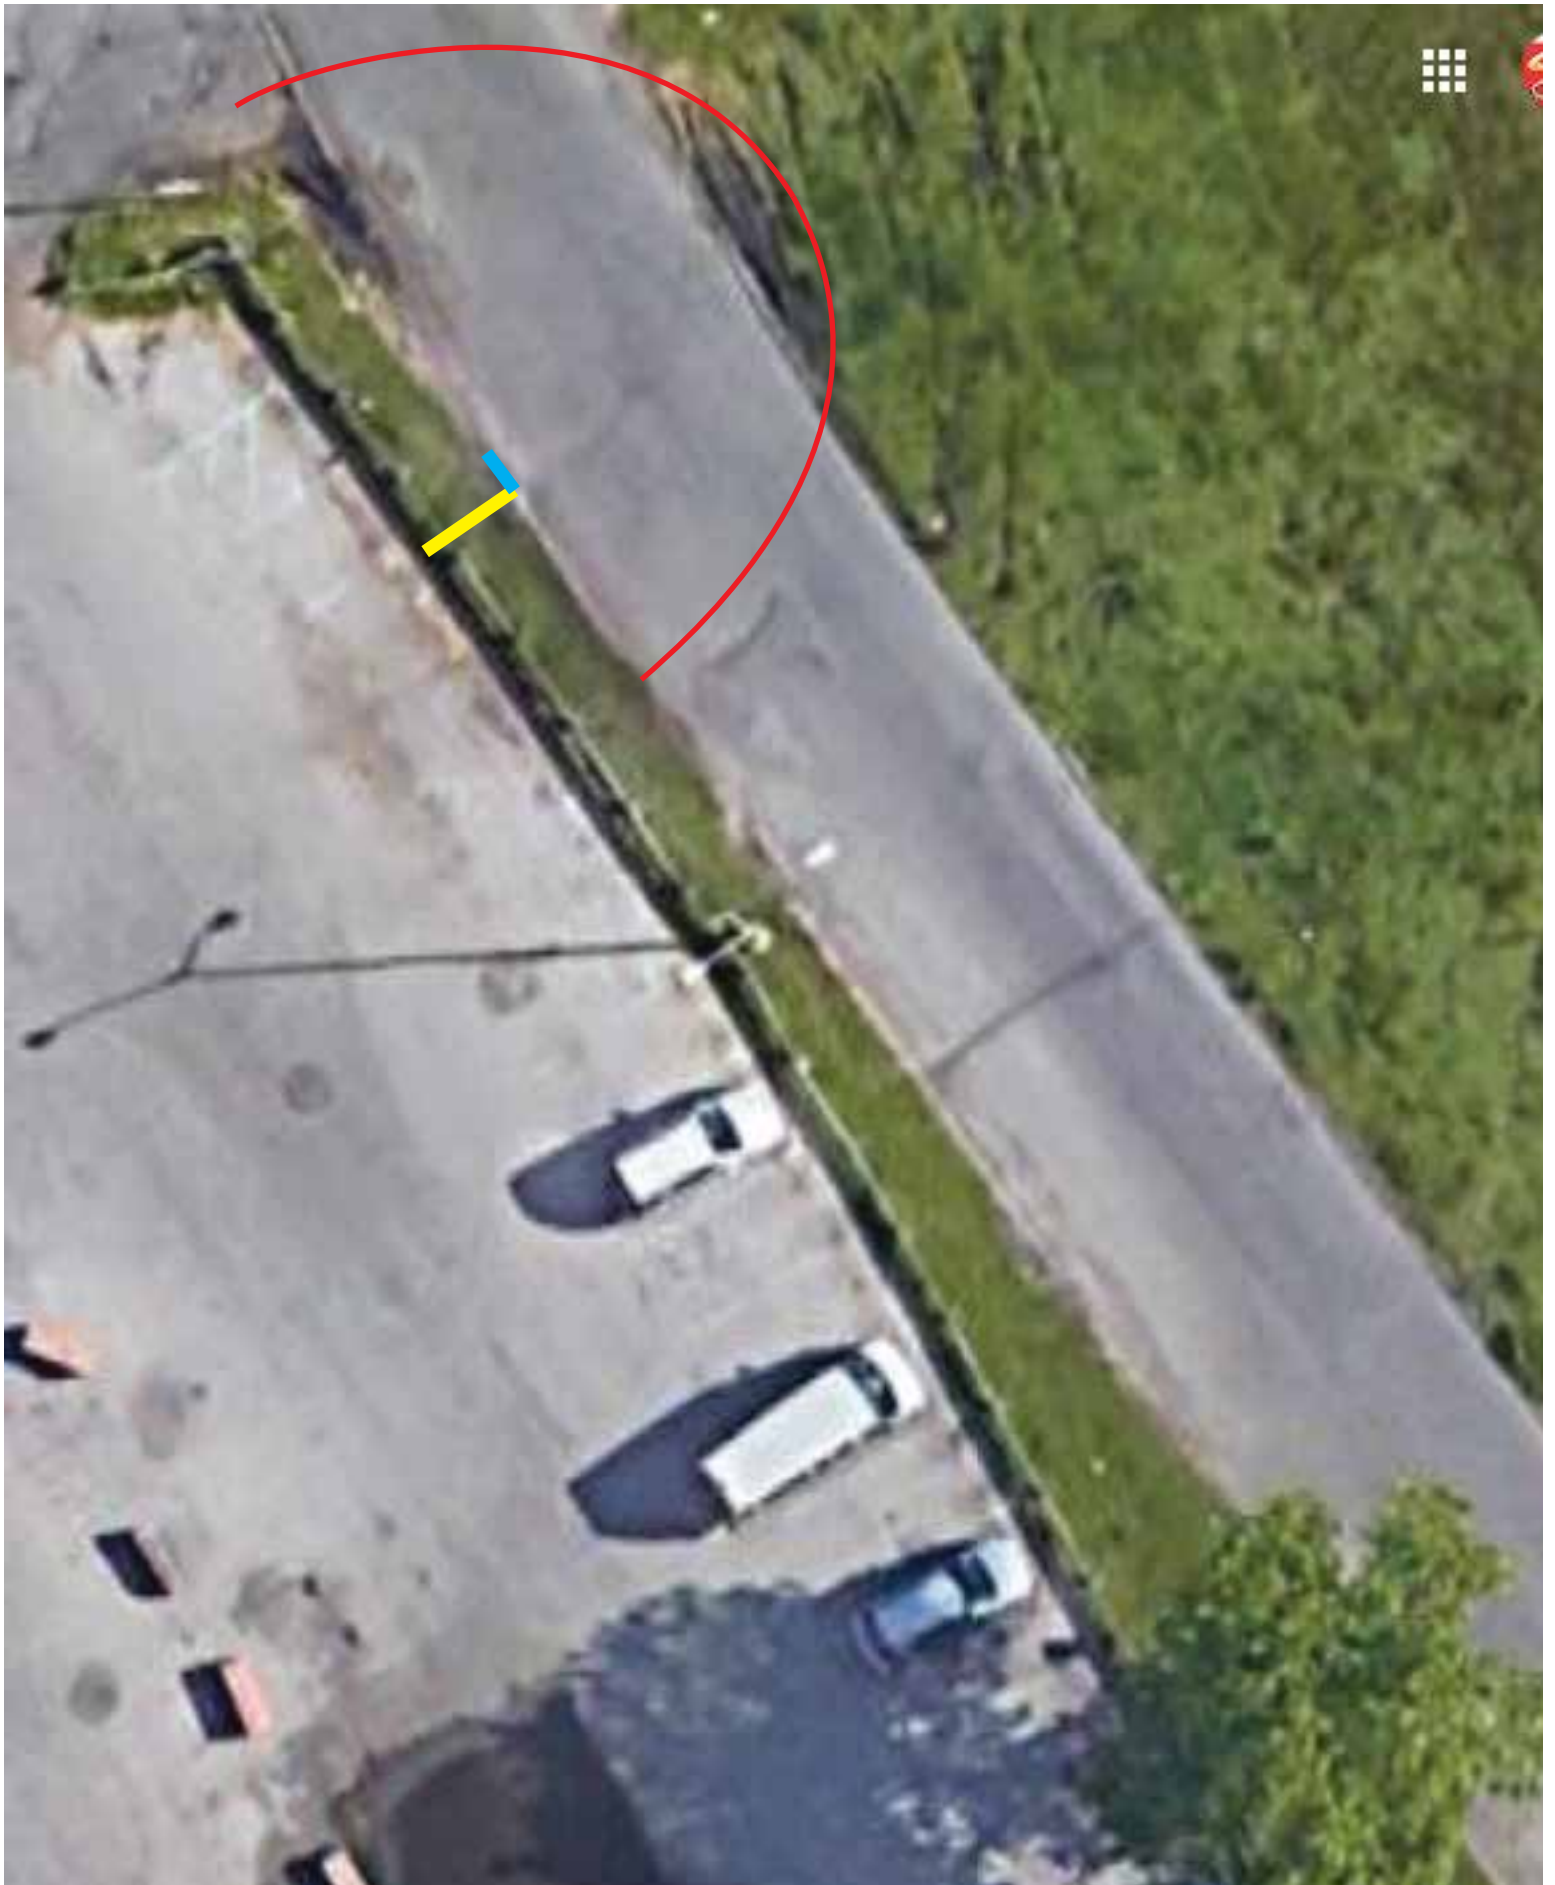
Status: complete

Channel drain and PVC drainage pipe  
was installed to remove water from this puddle

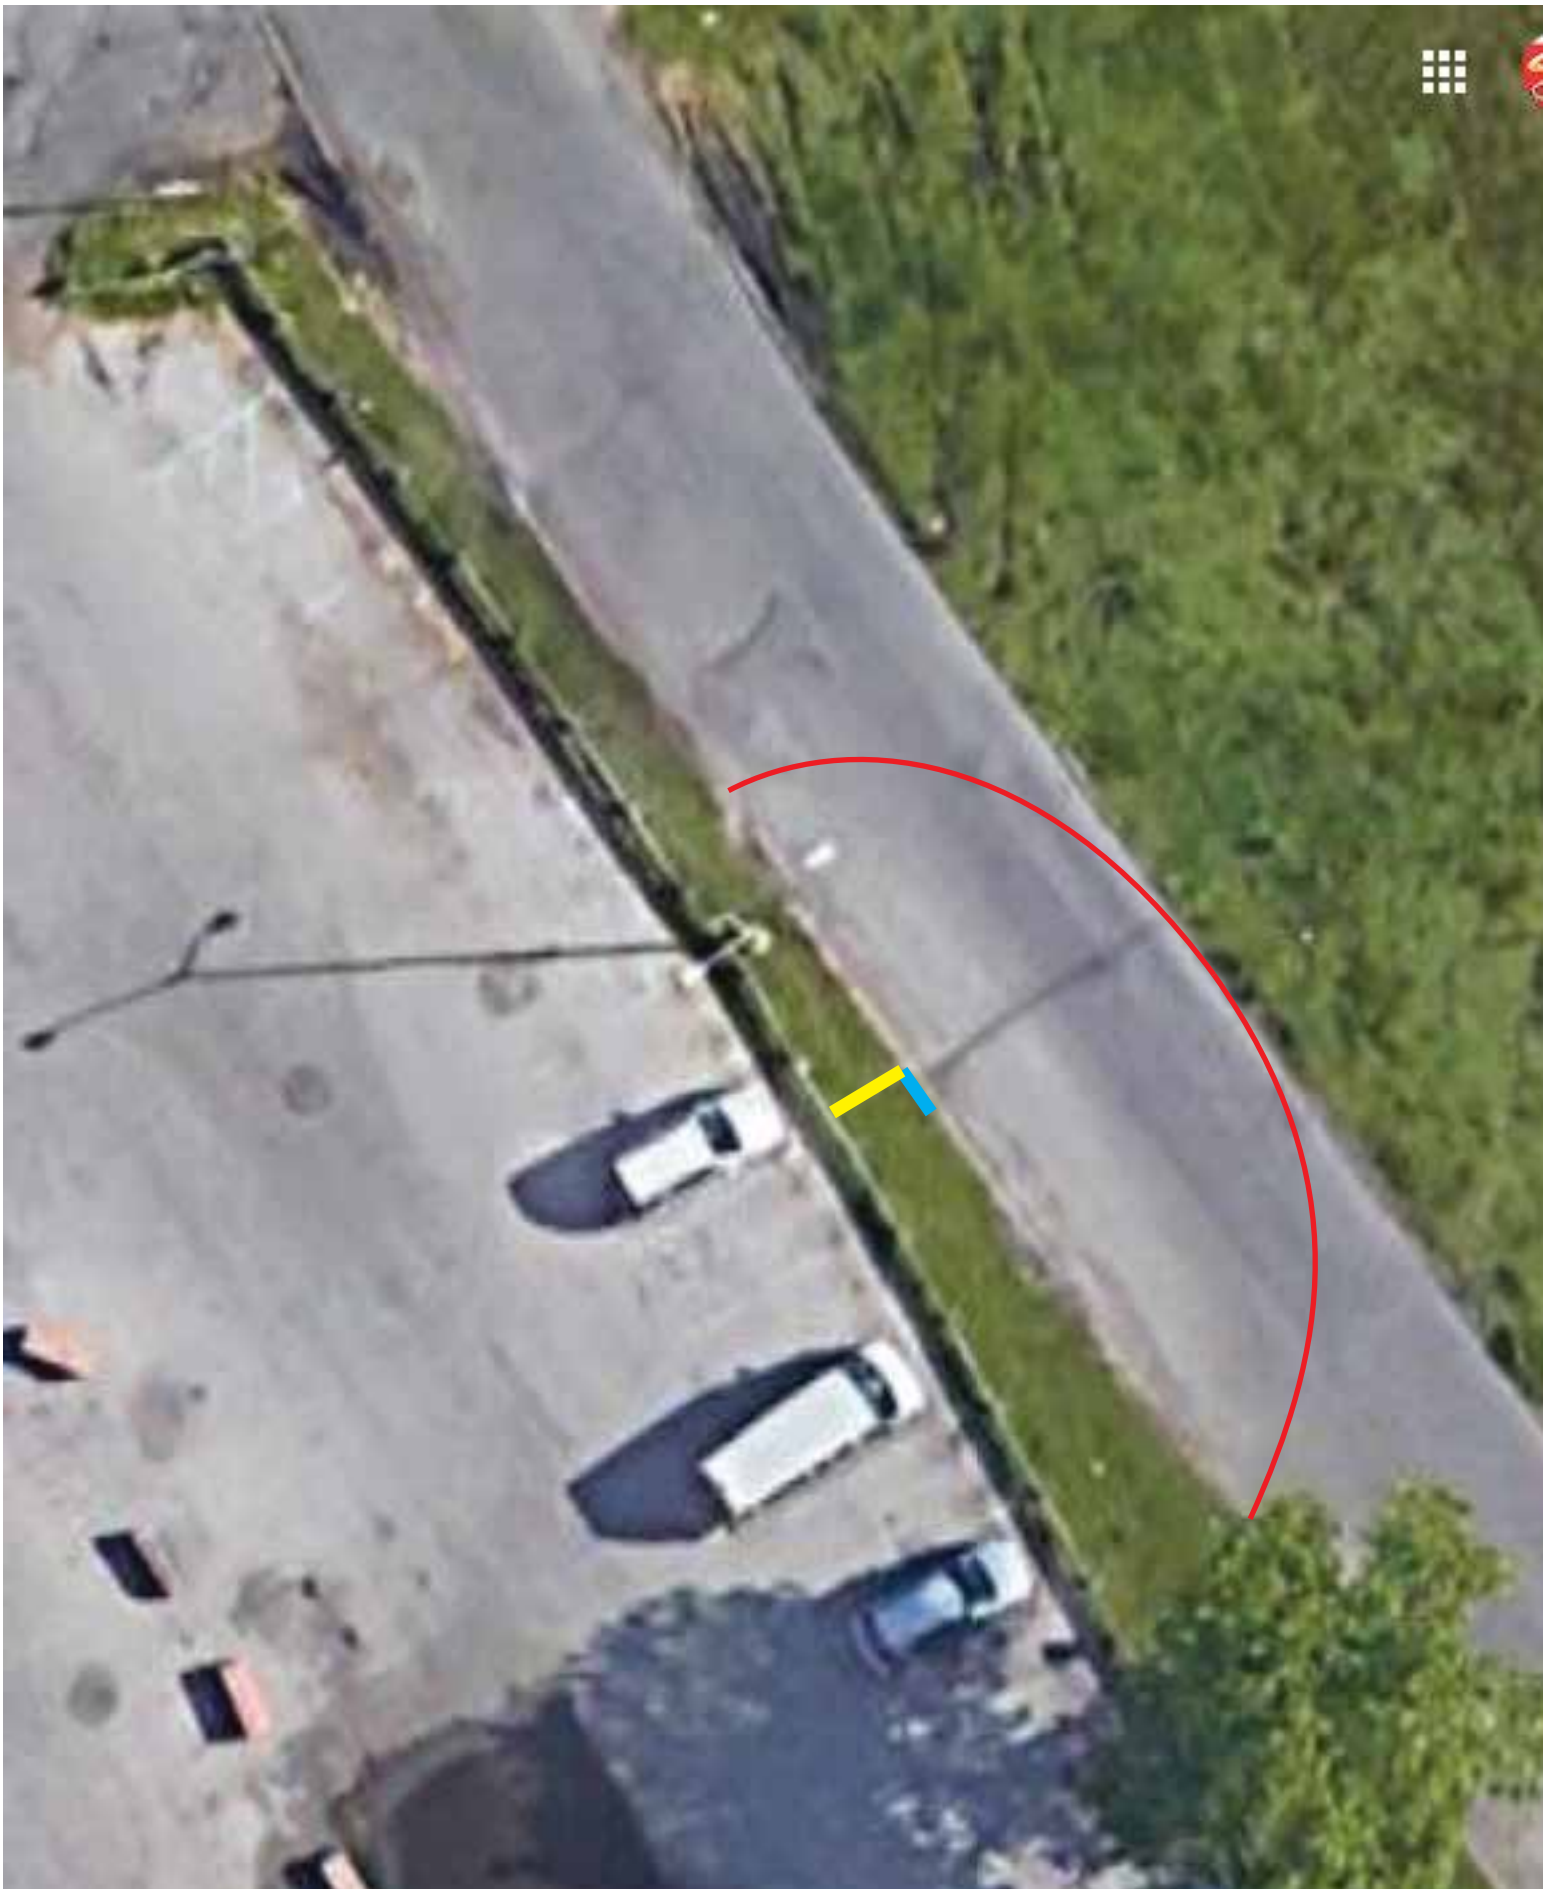
Status: complete

Channel drain and PVC drainage pipe  
was installed to remove water from this puddle
