Current status of storm drainage systems installed at FMCP

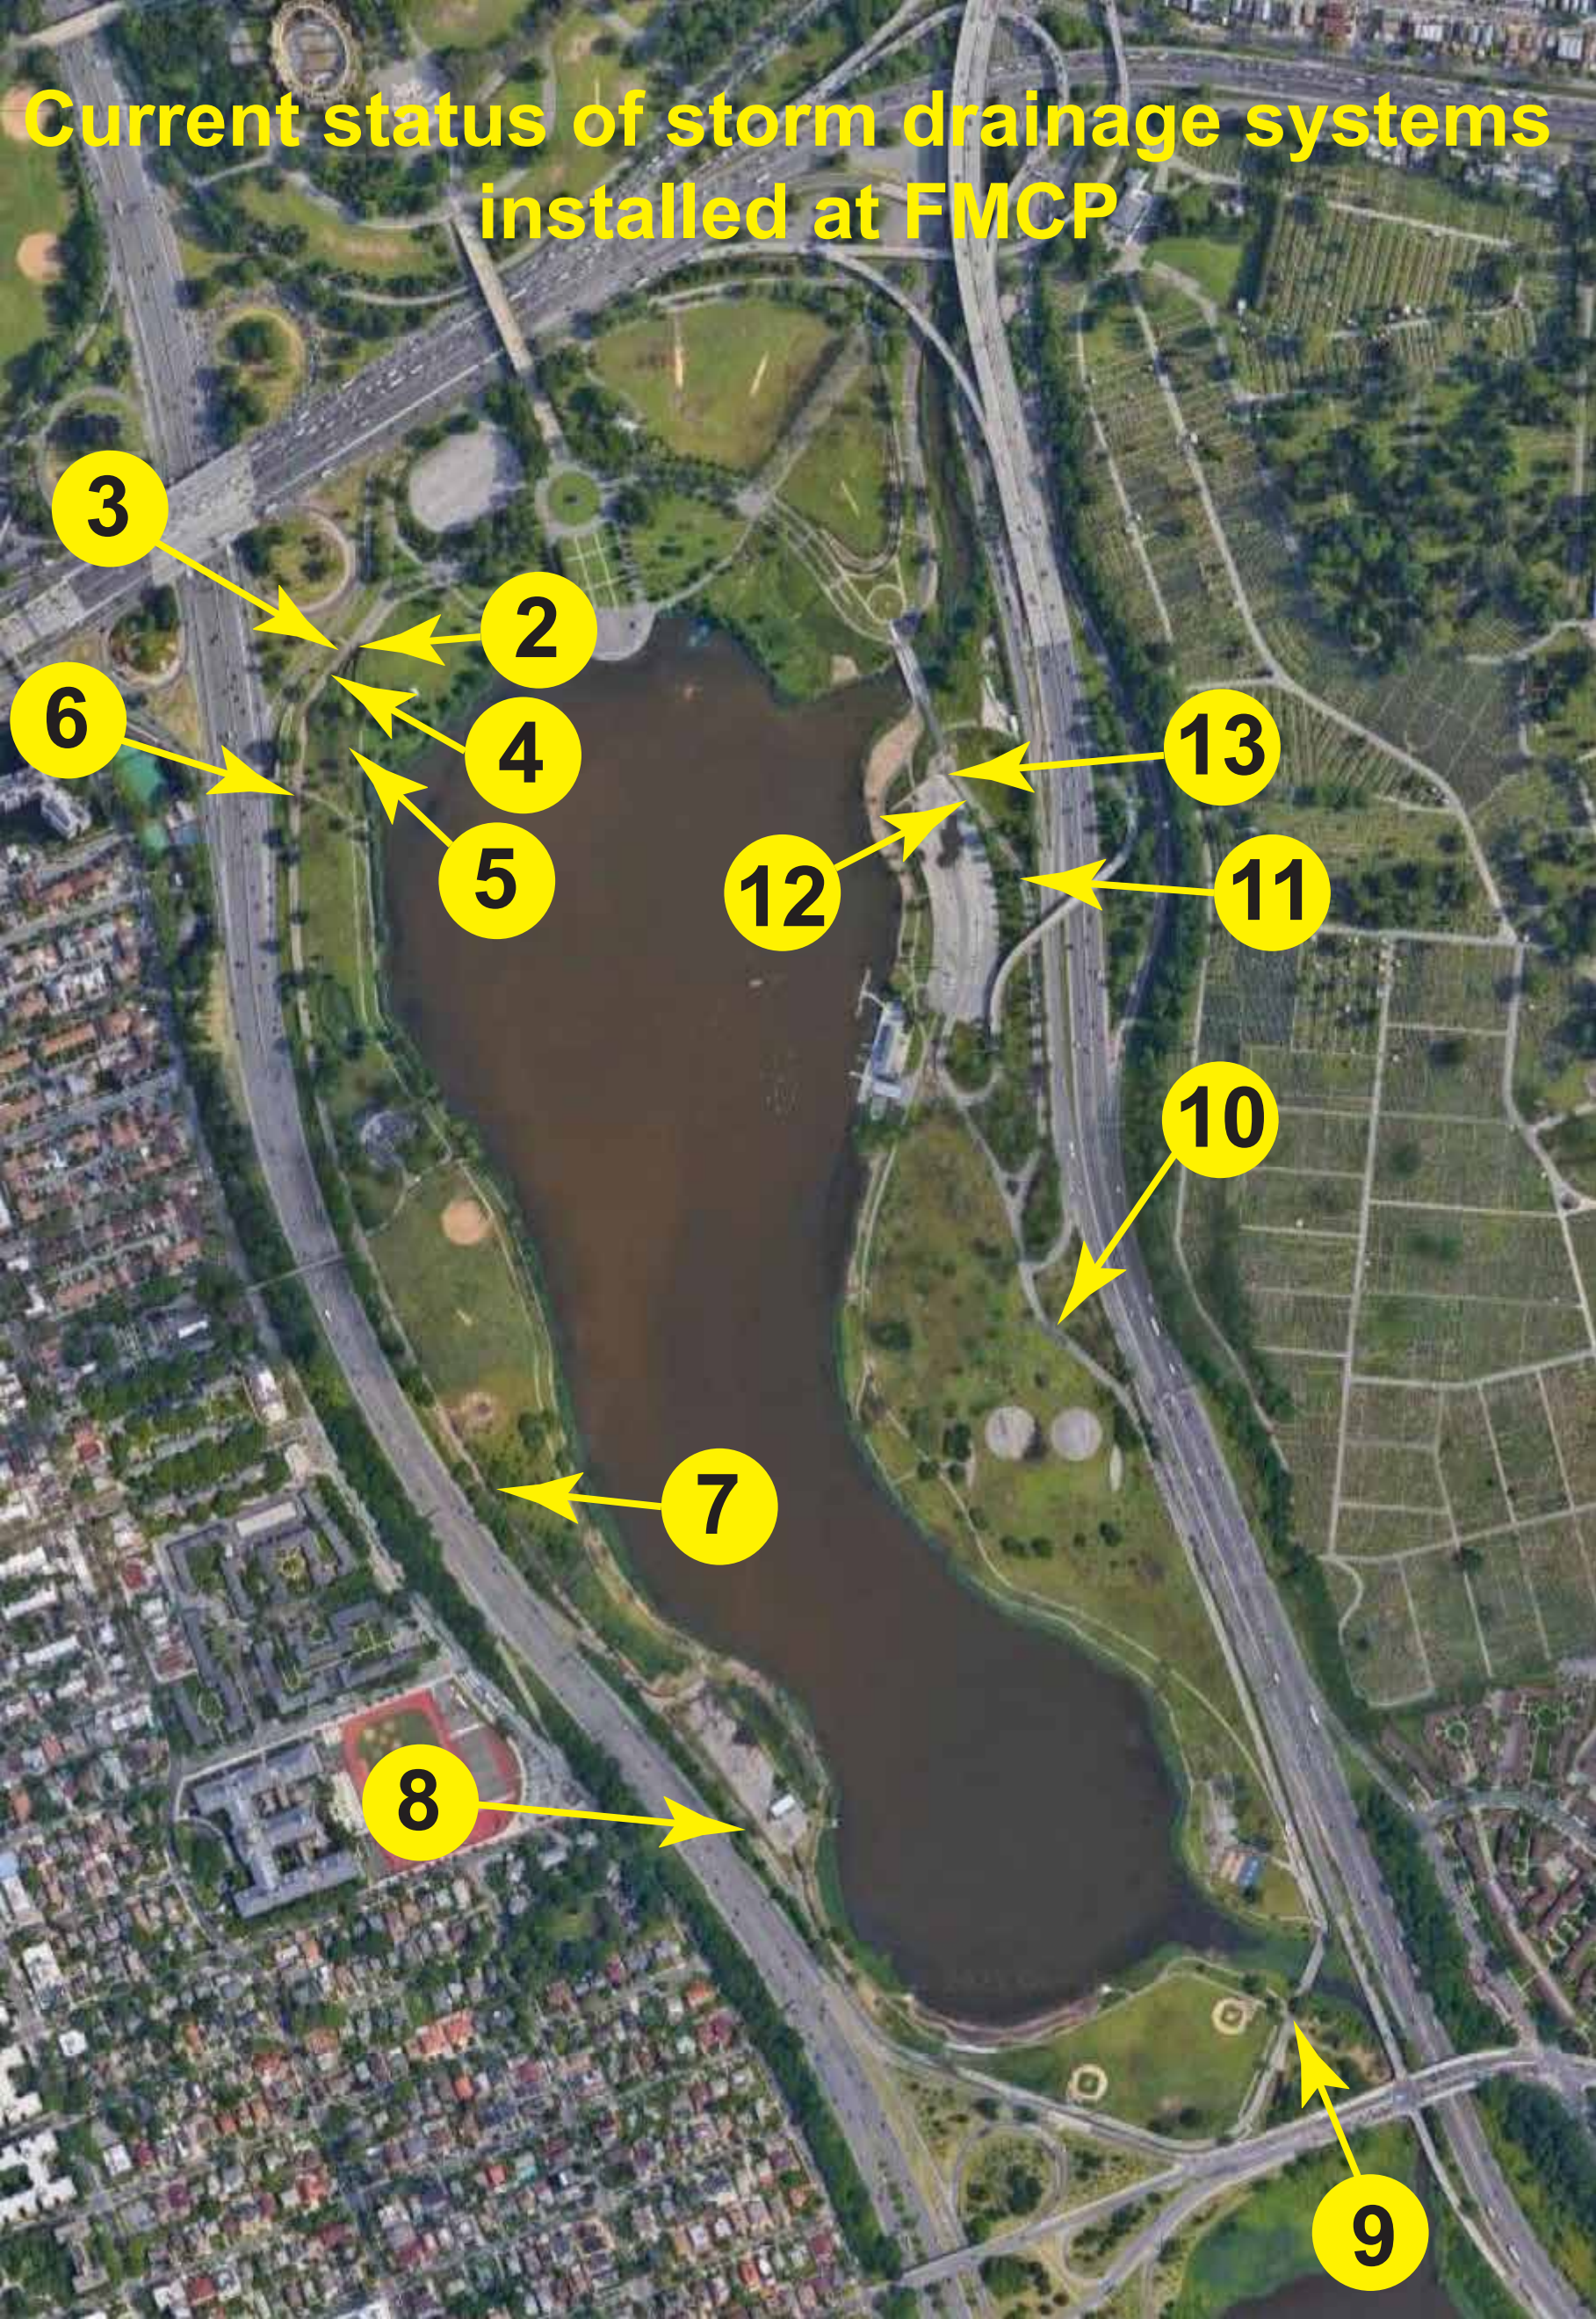
I suspect pipe rupture underground.  
Water comes out at much higher spot than anywhere  
around and refilling puddle pictured at page 3. I removed  
soil to the curb from paved roads around while I was trying  
to locate the source of the water.  
Needs further investigation.
